**BISHOP PAIUTE TRIBE
ENVIRONMENTAL MANAGEMENT OFFICE**

PRECIPITATION CALIBRATION TESTS

August 12, 2009

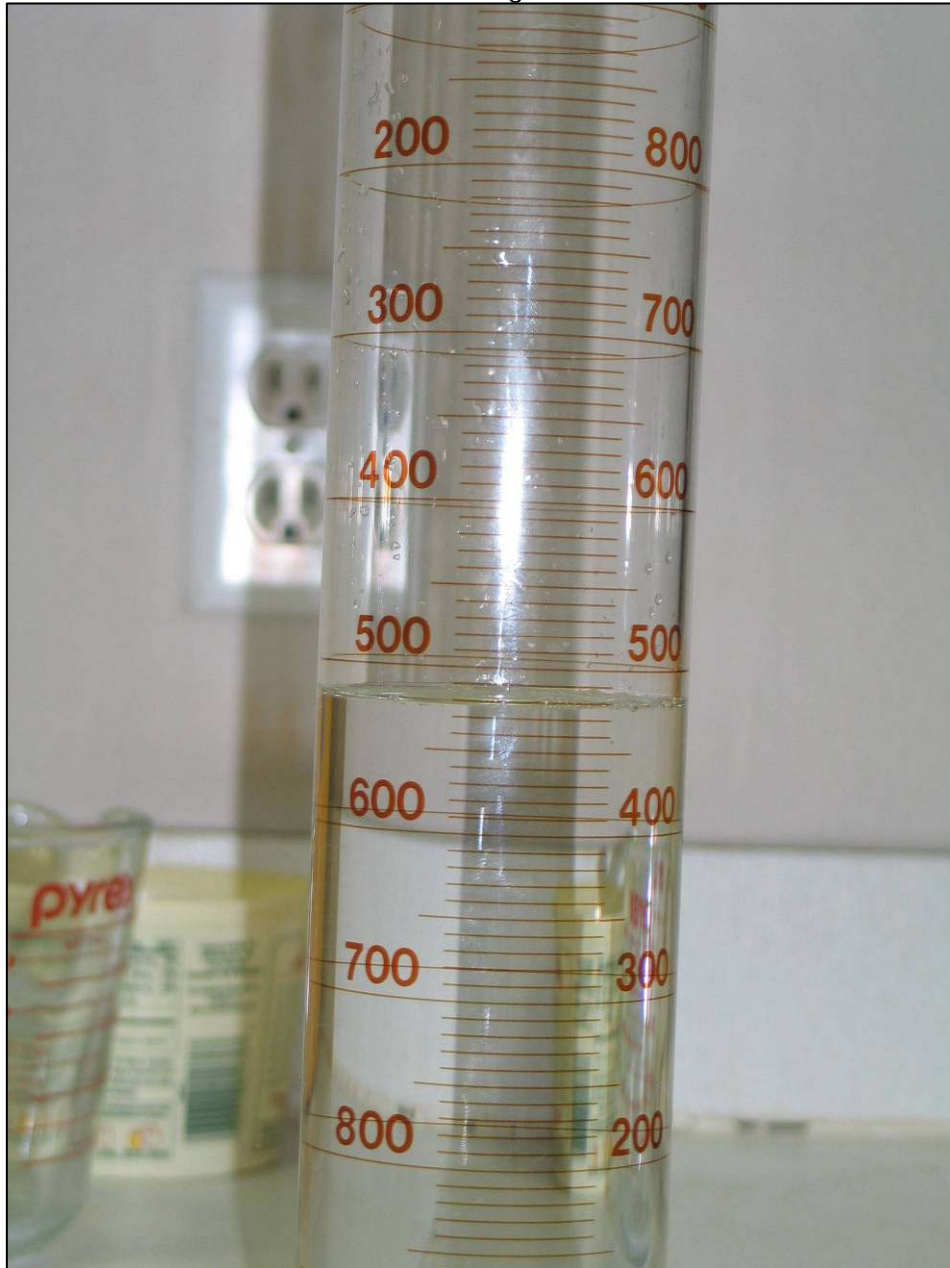
As a consequence, we verified the volume of water in the beaker supplied as part of the kit using a glass laboratory beaker. A value of 473 ml had been supplied by Texas Electronics to GBUAPCD and we measured 470 ml, although it is unlikely that we could have detected such a small difference in our large beaker and such a small difference would not significantly alter our results. Even after several try's, the volume was reproducible. See photograph below.

Meniscus on 1000ml beaker after being filled with water from FC-525 kit

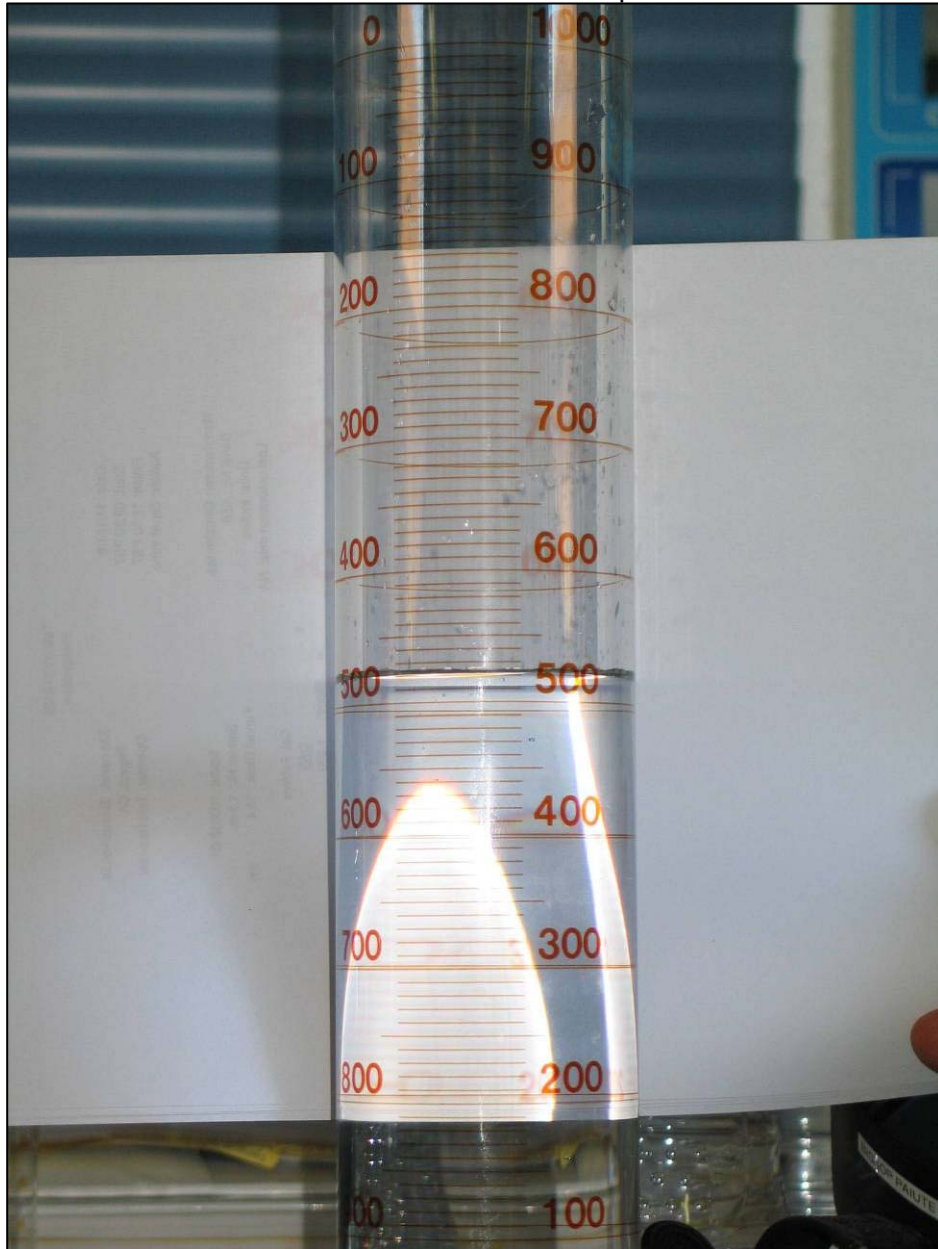
We then set up a test replicating the T&B Gatorade bottle / water bottle method. We discovered that Gatorade is no longer supplying that type of bottle in our area and substituted a similar Propel bottle, with the bottom removed so that it could serve as a funnel. For the water, we used 500ml Sparkletts drinking water. To make the test fair, we made sure that both the FC-525 funnel equipped with the brass #65 nozzle and the propel dripped at approximately the same rate. In addition, we measure the volume of a "full" Sparkletts bottle – one where the water was near the rim just below the cap on the bottle. We found this type of bottle typically contained 520ml of water. See the photograph below.

Minuscus from contents of a 500ml Sparkletts bottle

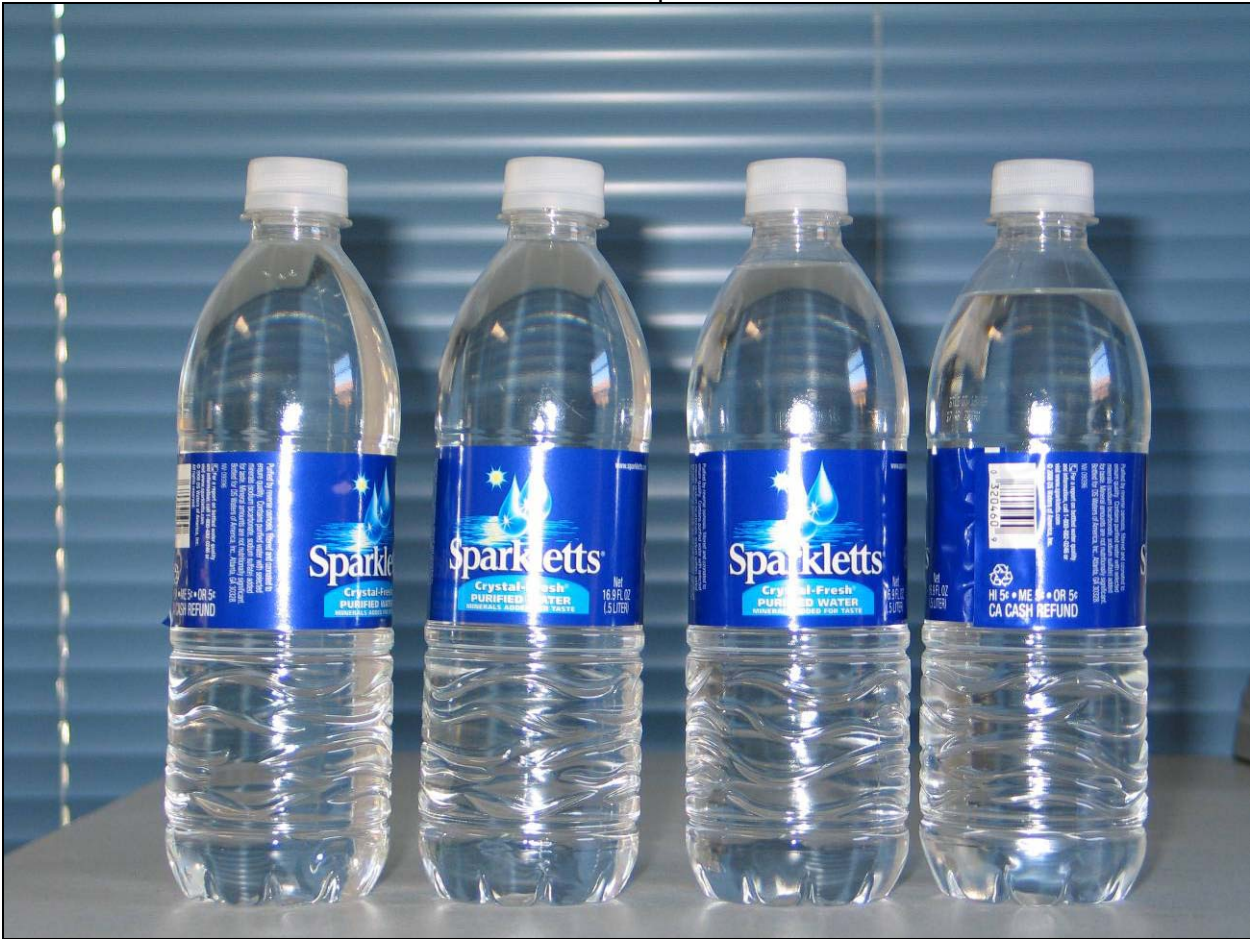
In the process, we noted that there appears to be some variability in the volume of water in Sparkletts bottles. All of the bottles in the next photograph are from the same case purchased from Smart and Final.

Volume of water in Sparkletts bottles
